3.3 Water

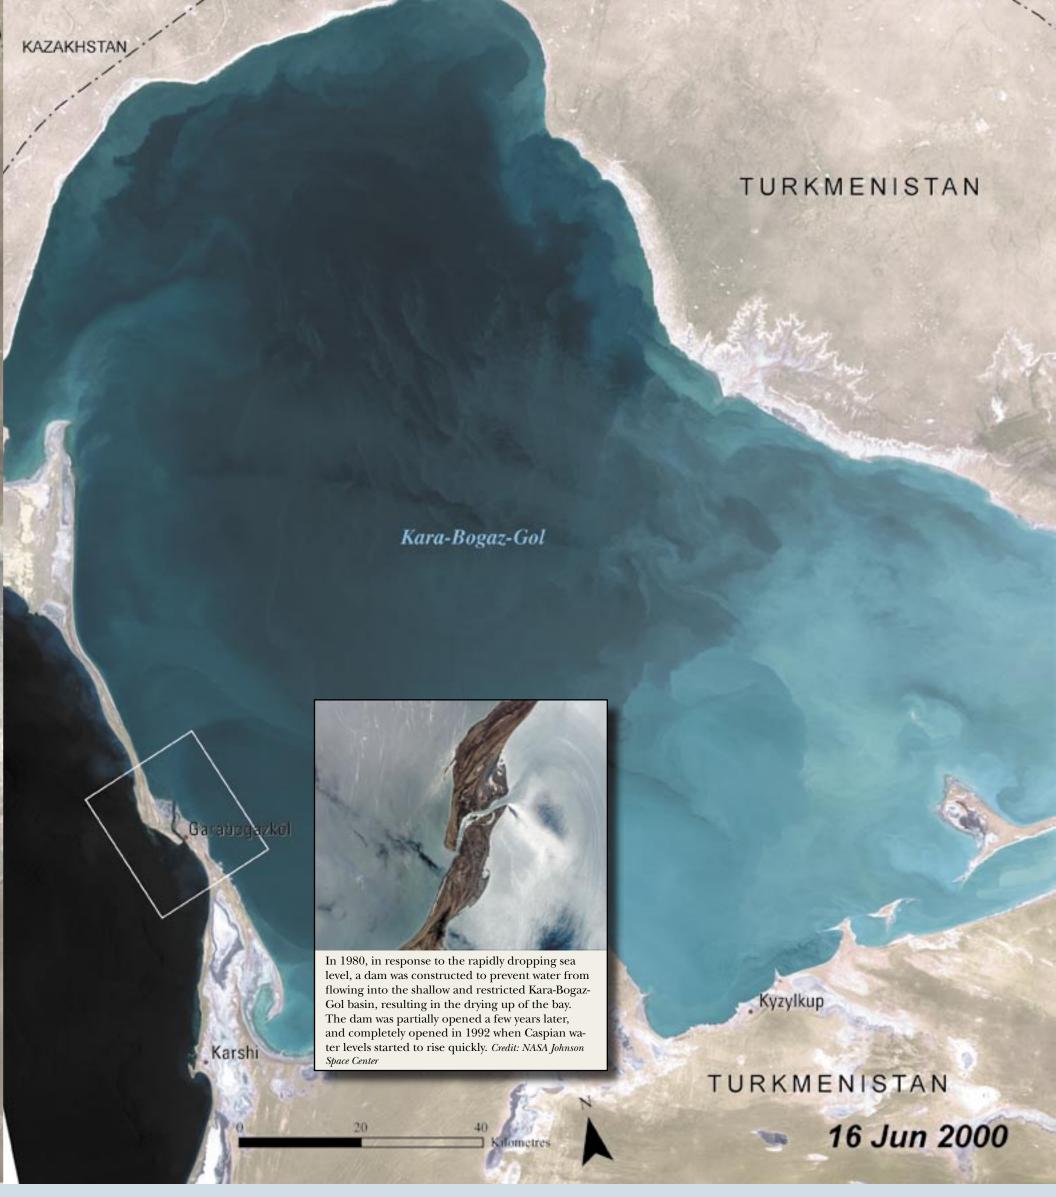
through evaporation, and the dissolved salts remain. Changes in water levels are common in the sea, resulting both from changing climatic factors and water diversion by humans. The 2004 image highlights the area of change—the Kara-Bogaz-Gol (KBG). KBG is a large, shallow lagoon of the Caspian Sea, normally about 18 200 km² (7 000 square miles) and a

few metres deep. The Caspian's changing water level has been a concern since the 1970s. The KBG's water flows in from the Caspian Sea, and its fluctuations have affected the KBG dramatically.

In the 1980s, a dam blocked the KBG's inflow, resulting in the formation of a "salt bowl" that caused widespread problems of blowing salt,

reportedly poisoning soil, and causing health problems for people living hundreds of kilometers downwind to the east. While the dam was in place, not only did the KBG's water level rapidly drop by 2 m (7 ft) or more, but the lagoon's shallow bottom also rose 0.5 m (2 ft), due to the accumulation of salts.

The dam was partially opened in 1985, and completely opened in 1992 when Caspian Sea water levels started to rise quickly. Today, sea levels are more than 2.6 m (9 ft) higher than the 1978 levels and water flows freely into the salty waters of the Kara-Bogaz-Gol.

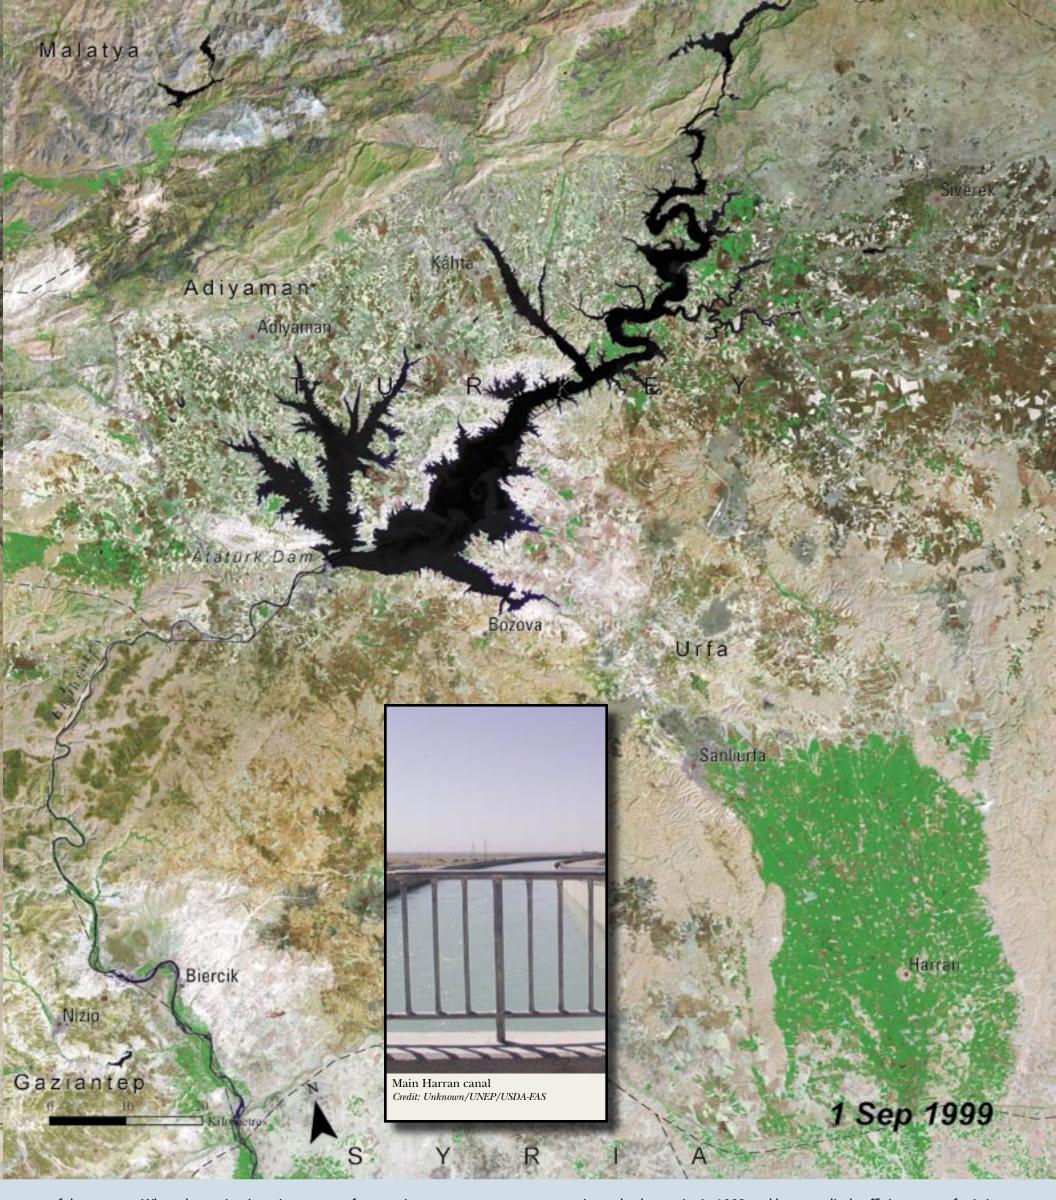
In these two Landsat images, acquired in 1976 and 1999, respectively, the transformation of the region around the dam is strikingly apparent. The dam's

reservoir reached capacity in 1992 and has supplied sufficient water for irrigation to turn a once-arid landscape into a green one. This is especially obvious in the lower right-hand corner of the 1999 image, where irrigated fields completely surround the town of Harran. The development of the Harran region could not have occurred without the Atatürk Dam project, especially since the town is many kilometres from the river.

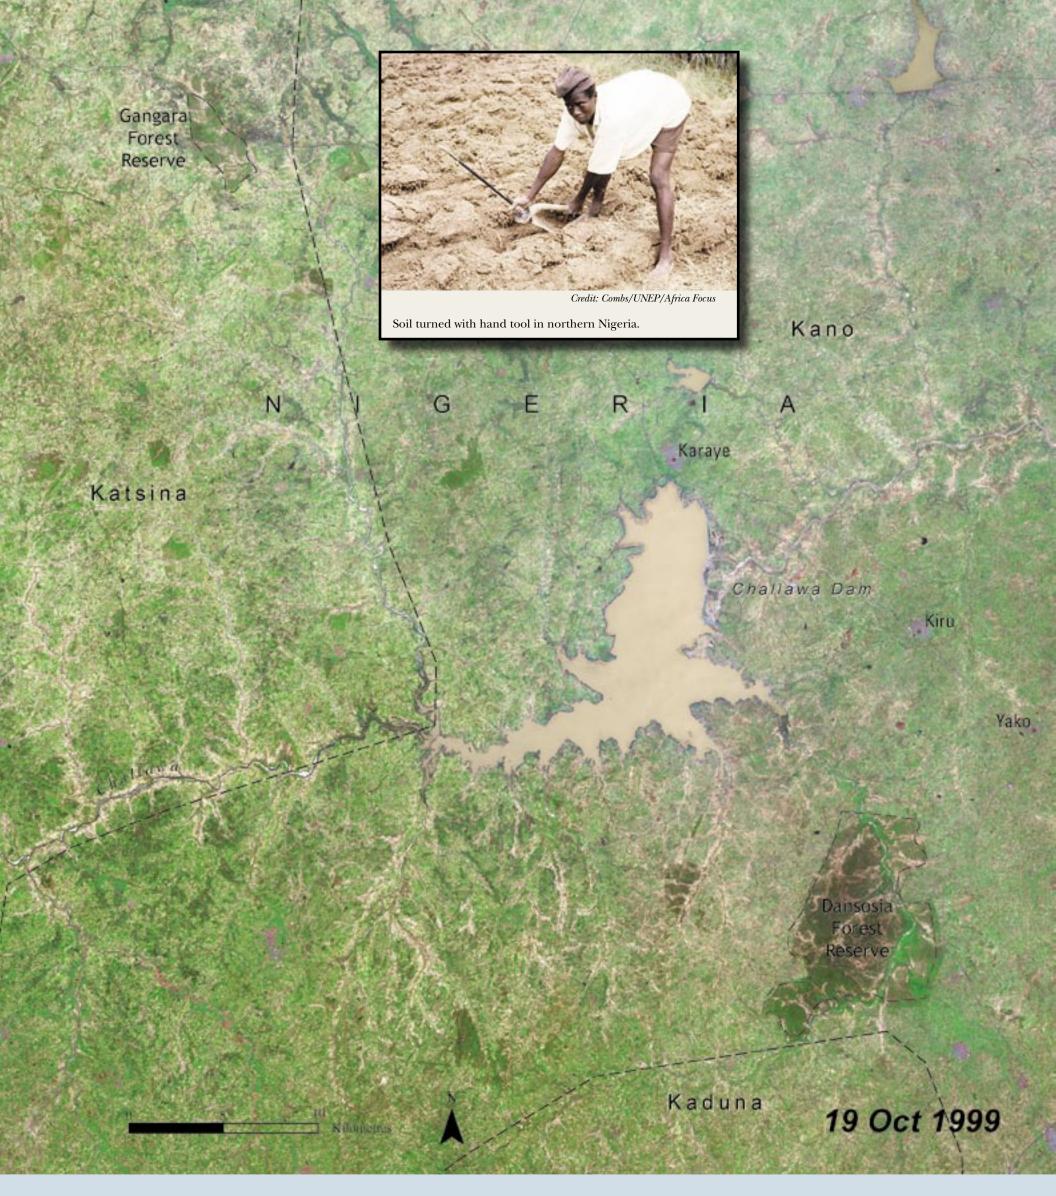
This satellite image pair gives a comparison of the area before and after construction of the dam. The 1999 image shows the degree to which flooding upstream from the dam impacts the landscape, and how the lack of water downstream negatively affects riverine wetlands and cropland. The colour of the water in the flooded area is also indicative of high-sediment content.

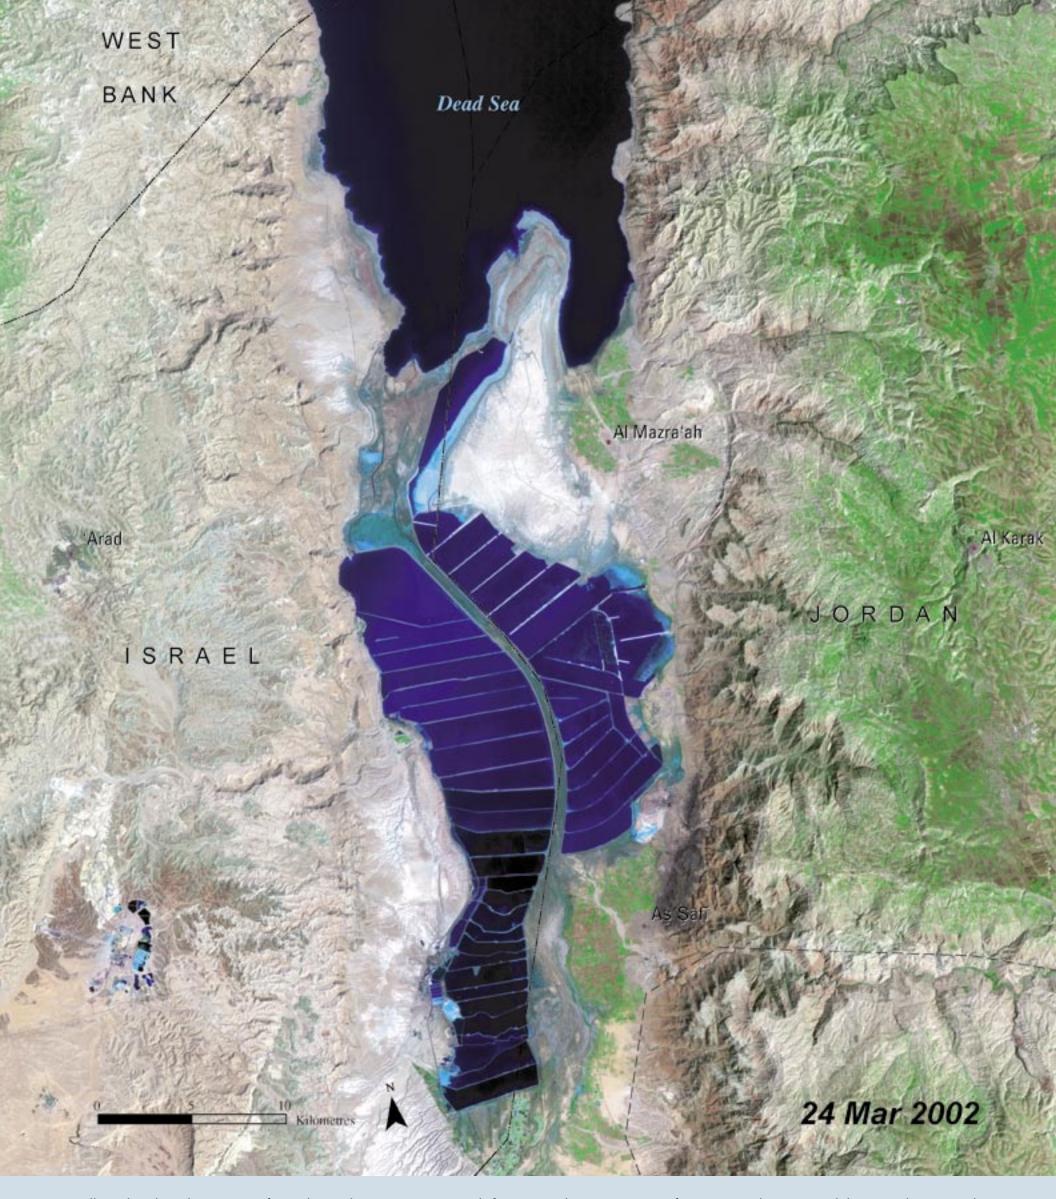
These two images, from 1973 and 2002, reveal dramatic changes in the Dead Sea over a period of about 30 years. Declining water levels, coupled with impoundments and land reclamation projects, have greatly increased the amount of exposed arid land along the coastline. The near-complete closing off of the southern part of the Sea by dry land (2002 image) reveals the severity of water level decline.

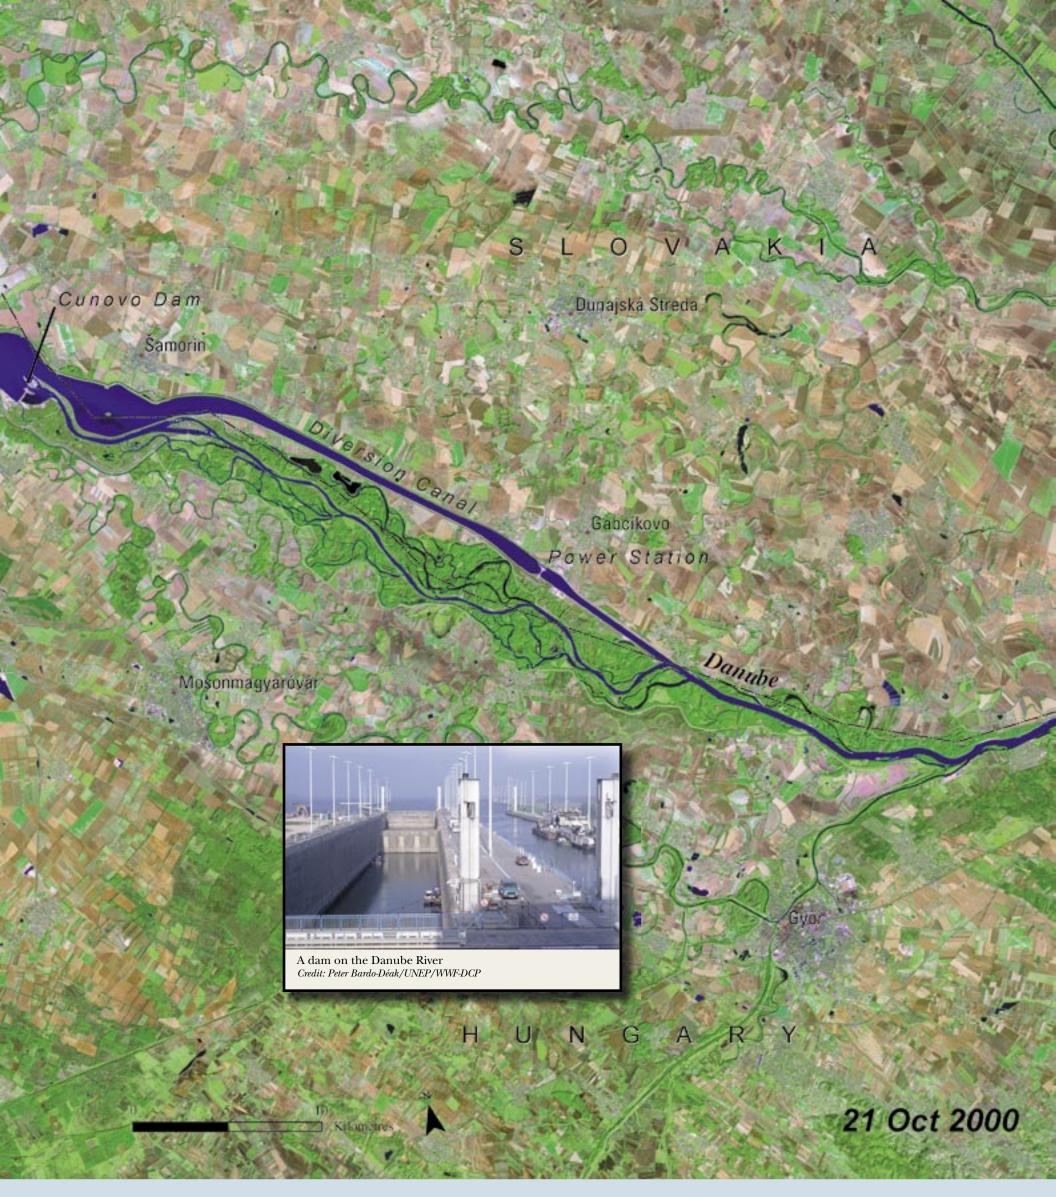
Cunovo Dam began operation in Slovakia in October 1992. The dam diverted 80 to 90 per cent of Danube River water down a diversion canal to support a hydroelectric power station.

This pair of images from 1973 and 2000 reveal the striking changes the massive re-channeling of river water has brought to the region. The dam altered the hydraulic regime of the Danube River valley from a natural water-

way to a controlled patchwork of channels and islands. The diversion of water by the dam brought an end to the natural, beneficial flooding that added moisture and nutrients to the soil. It also reduced the ability of wetlands and marshes to filter surface water and trap sediments. Consequently, water quality and soil nutrients levels in the region have declined. Generation of electricity has come with significant environmental cost.

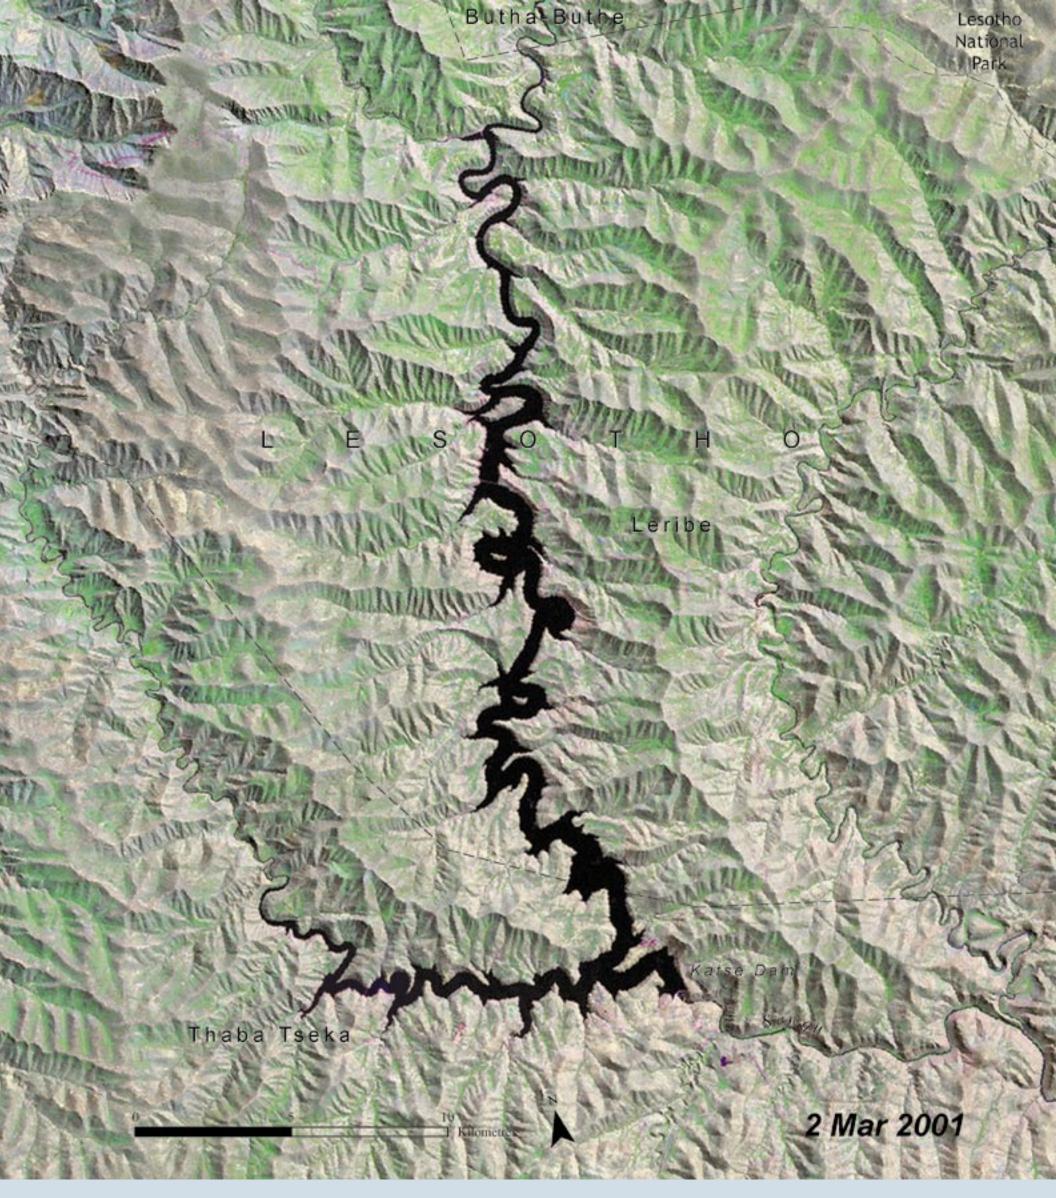
These two images provide a comparison of the area before and after completion of the Katse dam. The effects and extent of the Katse Dam can clearly be seen in the 2001 image.

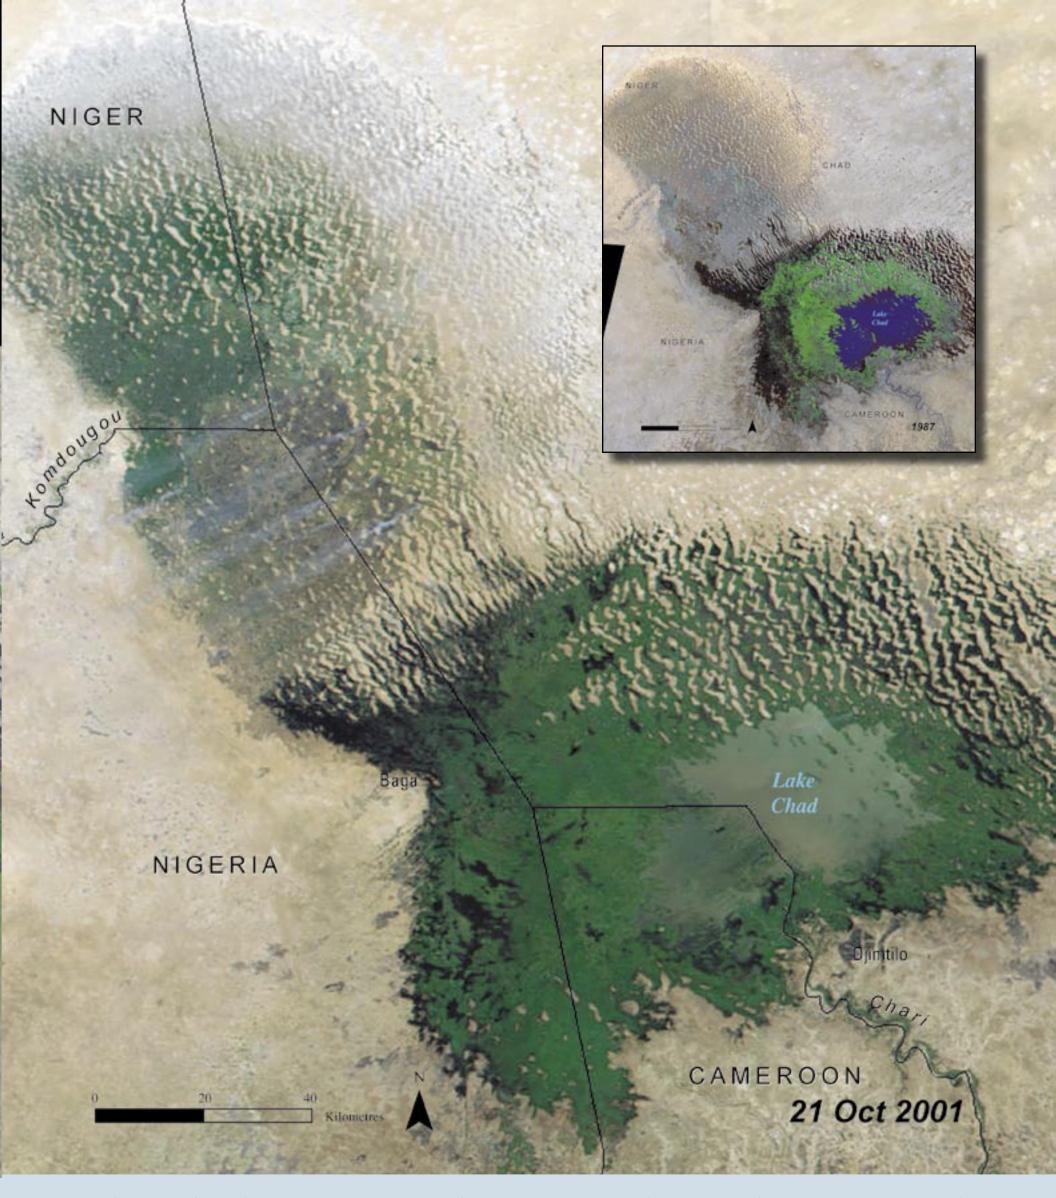
This image set displays a continued decline in lake surface area from 22 902 km² (8 843 square miles) in 1963 to a meager 304 km² (117 square miles) in 2001.

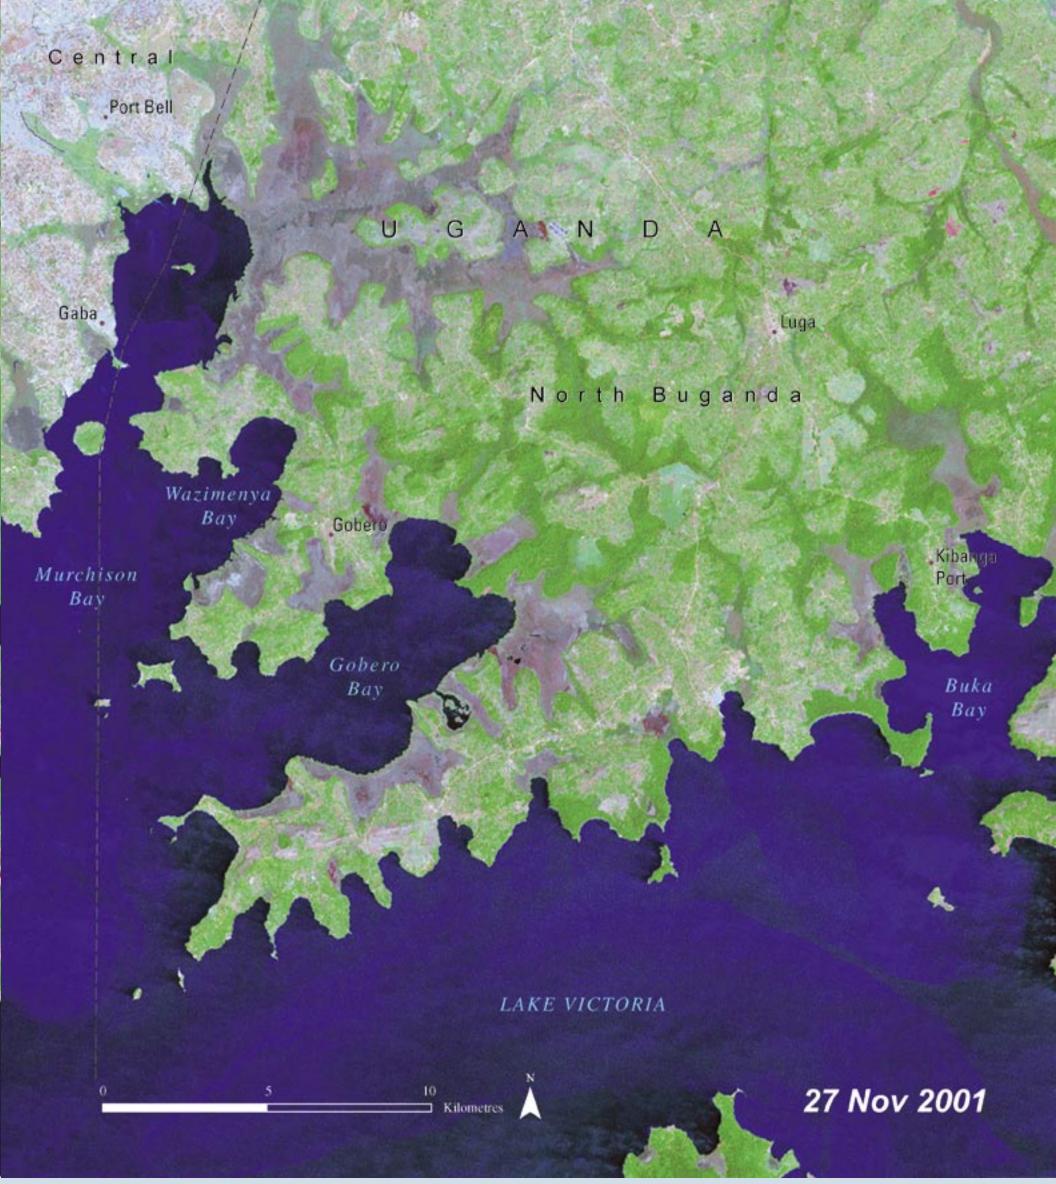
The 1995 image shows several water-hyacinth-choked bays: Murchison Bay near Gaba; large parts of Gobero and Wazimenya Bays; an area outside Buka Bay; and near Kibanga Port (yellow arrows).

Initially, water hyacinth was controlled by hand, with the plants being manually removed from the lake. But re-growth quickly occurred. A more recent control measure has been the careful introduction of natural insect predators of water hyacinth. As the 2001 image shows, this approach seems to have been successful, as the floating weeds have disappeared from all the locations noted above.

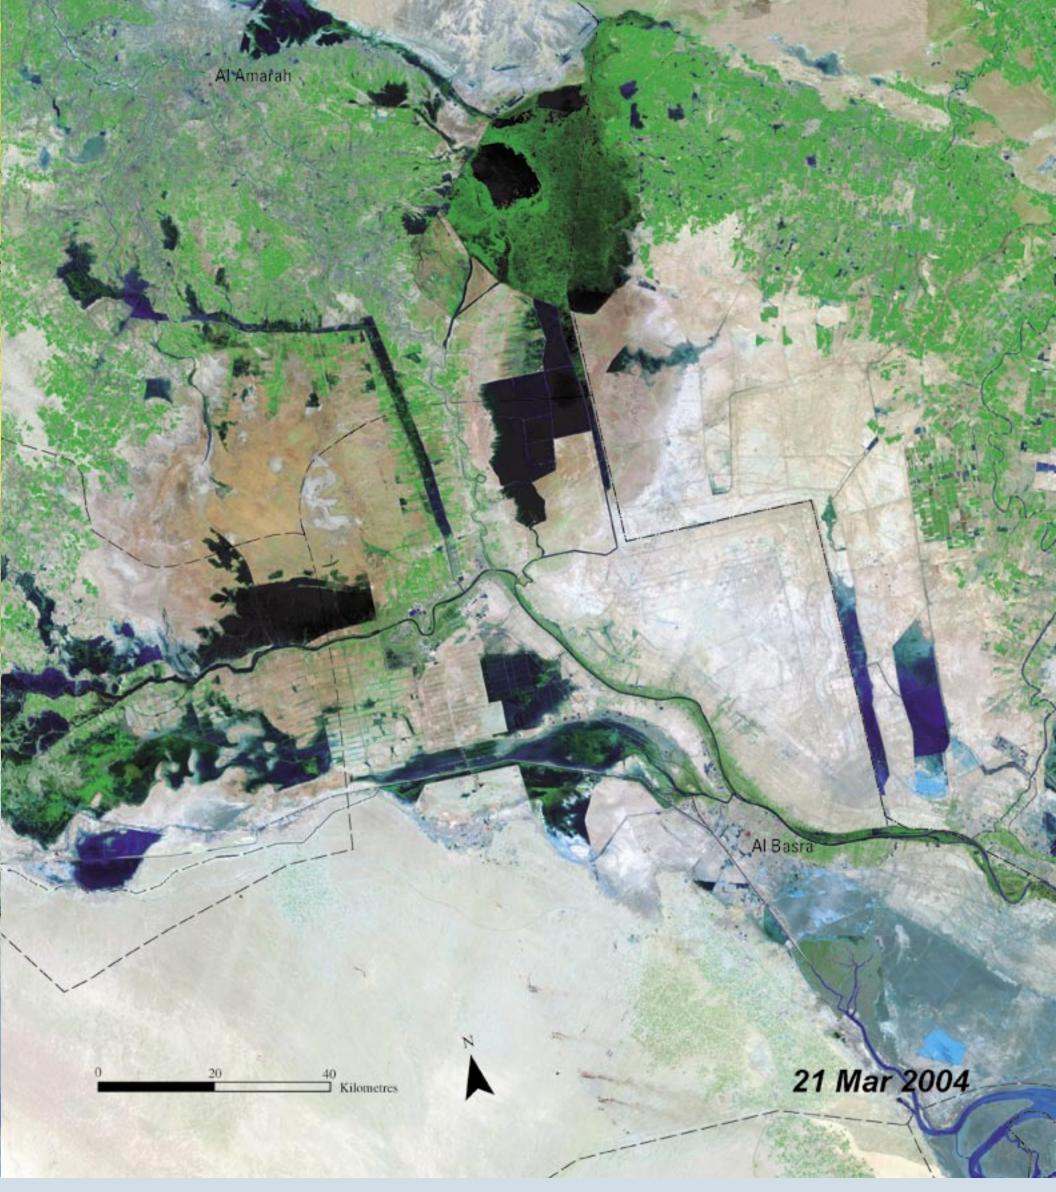
This set of images provides a synoptic illustration of the changes. While the 1973 image (inset left) shows the extent of the original marshlands, the 2000 image (inset right) reveals the area after being drained, with most of the wetlands having disappeared. On the other hand, the 2004 image illustrates recovery in progress with major portions in the central and western sections having been restored to some extent.

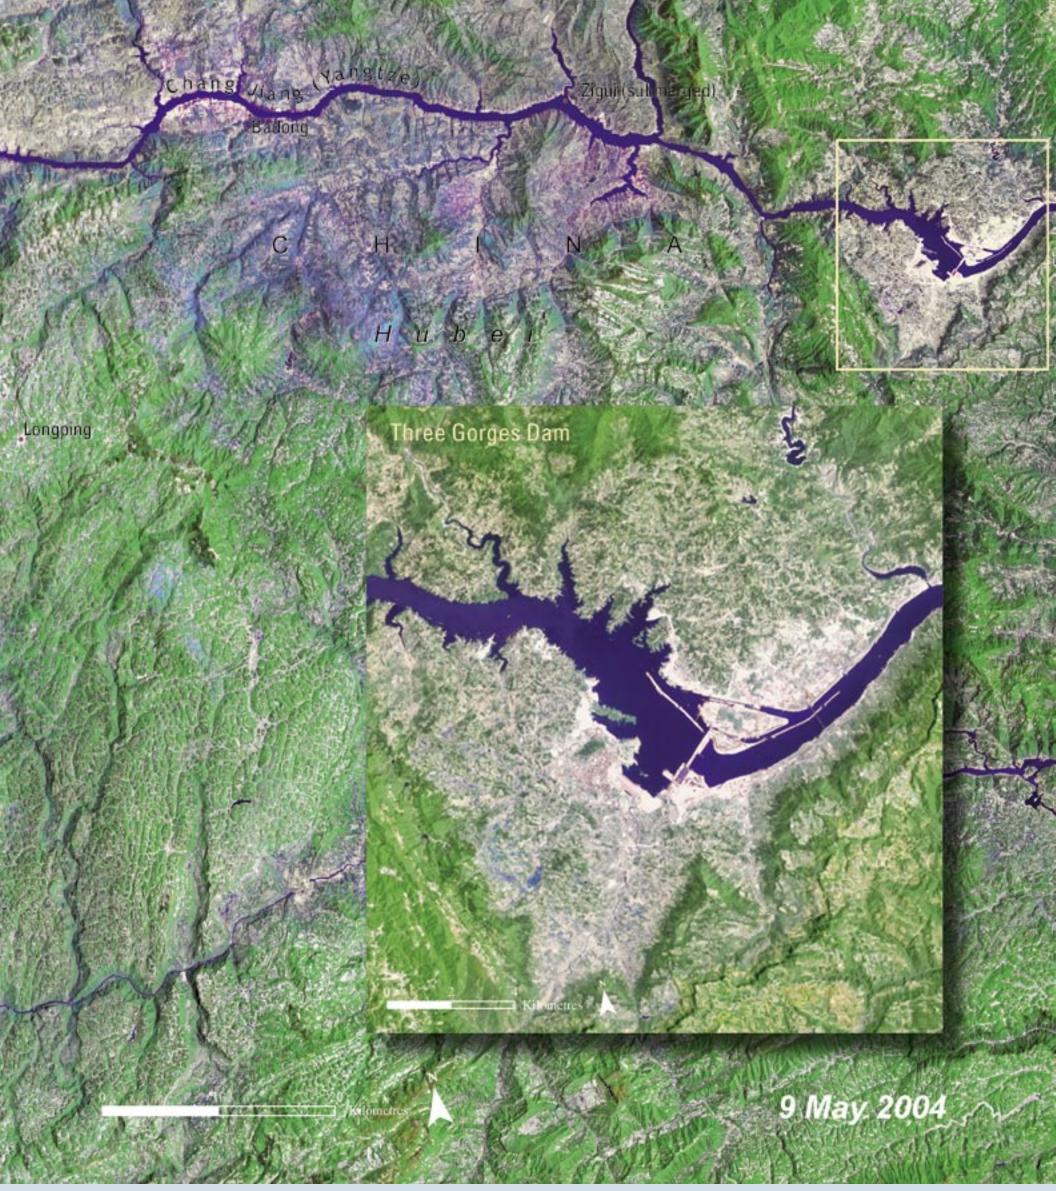
mergence of land along the river above the dam. The former village of Zigui (top center of image) has already been submerged.

The 1987 image shows the nature of the river and surrounding landscape before work on the dam was begun. In the May 2004 image, the enormous Three Gorges Dam is clearly visible, as is the reservoir of impounded river water that has been created behind it.
